Tank maintenance

Our guide to the economical repair of corroded tank bottoms

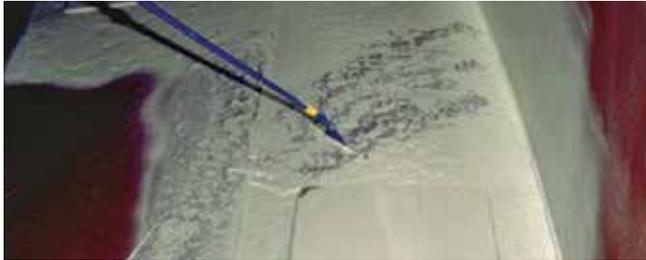
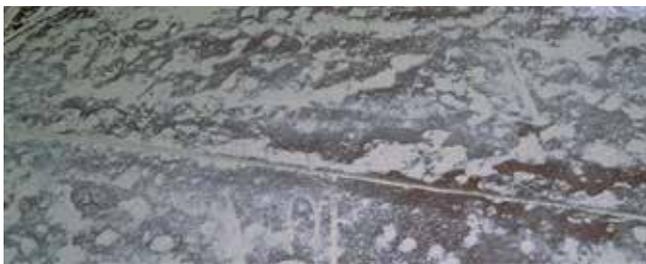
Legend:
Light blue: Caulking compound / stripe coat
Dark blue: Tank lining

In some situations, even after filling the pits, a caulking compound may be required to level the uneven areas. Our PPG NOVAGUARD 830 coating can be applied to all weld seams, lap joints, shell side joints or other surface projections to provide a smooth surface transition.

It is important that an even surface is provided by the caulking compound to assist in the application of the chopped fiber laminate to the tank bottom and joint areas.
