CASE STUDY

HOOPERN STREET, EXETER

REMEDIAL RAINSCREEN REPLACEMENT

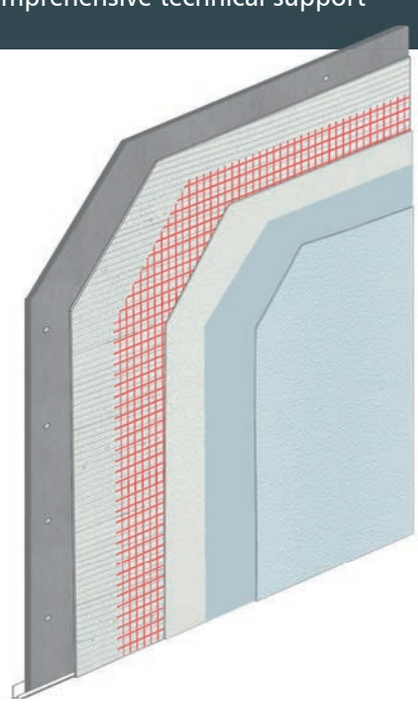
Site investigations identified several construction defects within the original façade, including inadequate timber restraint, poor cavity ventilation and incorrectly positioned movement joints. The replacement system needed to rectify these issues while maintaining fire safety, moisture management and long-term structural performance.

SAS Europe developed a complete remedial solution based around the ProWall Rendered Rainscreen System. Additional timber noggings were introduced to strengthen the timber frame before installing vertical counter battens to create a continuous 25mm ventilated cavity, ensuring effective drainage and airflow behind the façade.

The replacement system incorporated ProBoard cement render boards, ProRend Lite reinforced basecoat, ProMesh reinforcement mesh, Colourtex Primer and ProRend Colourtex Silicone Render, together with specialist ProWall ventilated base beads, slip joints, expansion profiles and intumescent cavity barriers.

Additional detailing included a rendered blockwork plinth, revised vertical expansion joints, reinstated movement joints at floor levels and improved detailing around the car port head to maintain continuous ventilation throughout the façade.
