Curing Lime Based Renders & Mortars

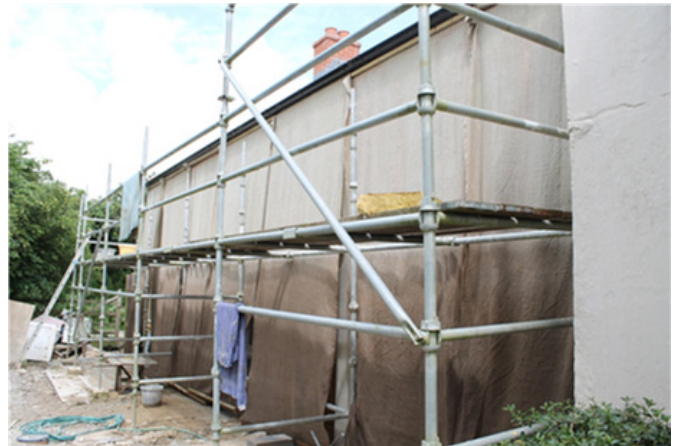
General view of hessian sheeting attached to the inner uprights of a typical inside board scaffolding. Summer working with the hessian dampened down to aid the curing regime.

Standard practice for protecting lime renders is with hessian sheeting draped over the subject area in relatively close proximity to the render. This should be left in place for at least a week and while this is a standard requirement for any kind of rendering it's one that is regrettably seldom practiced.

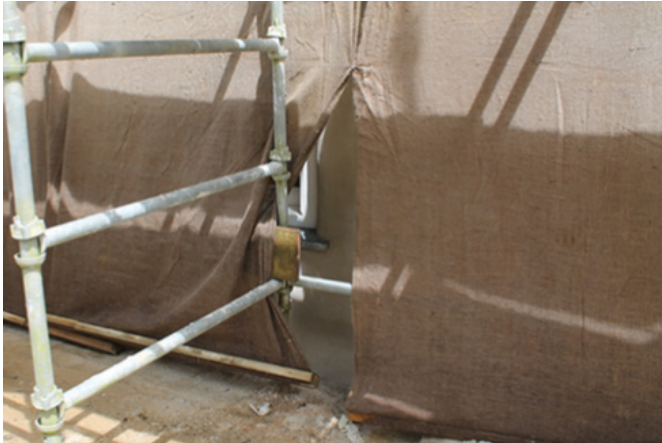
A simple yet effective arrangement at the base of scaffolding to manage hessian protection for a new lime render, note the use of a scaffold board and the 2"x1" batten to mitigate flapping.
