# CASE STUDY

## PROWALL REMEDIAL WORK AT QUARRY COTTAGE

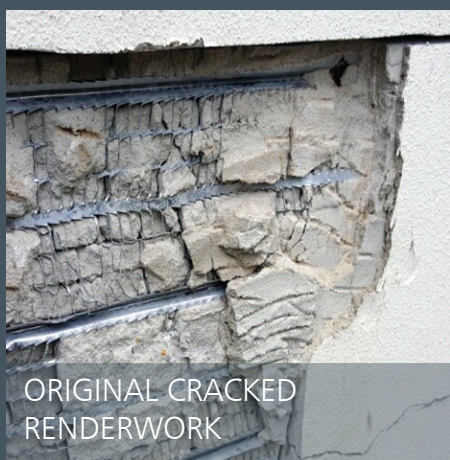
Family company DJP Finishes chose the ProWall rainscreen cladding system as a remedial solution for a badly cracked timber frame house. The existing render varied in thickness between 30mm and 60mm, and was embedded with expanded metal lathing (EML).

The repetitive expansion and contraction of the EML meshing in different temperatures had cracked the render around it. Water could then penetrate the cracks, saturating the render causing it to crumble when frozen.
