CASE STUDY

PROWALL REMEDIAL WORK AT QUARRY COTTAGE

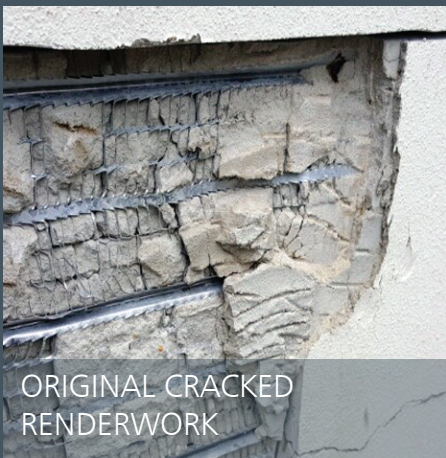
ORIGINAL CRACKED
RENDERWORK

The repetitive expansion and contraction of the EML meshing in different temperatures had cracked the render around it. Water could then penetrate the cracks, saturating the render causing it to crumble when frozen.

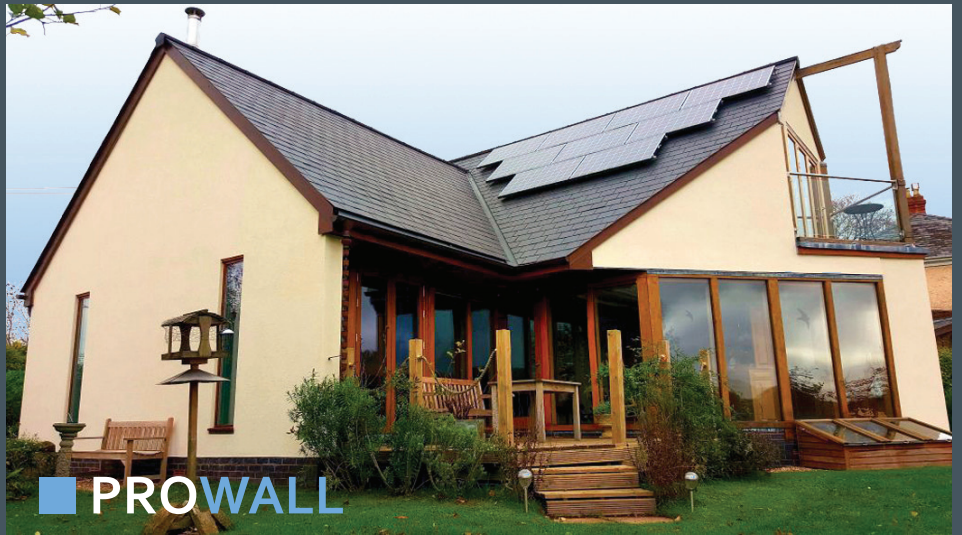
After removing the old render and battening, ProWall rainscreen was installed.

This included new battening, an advanced render carrier board, and ventilation beads to the top of the system under the soffits and at the base.

ProRend Lite basecoat was applied to the render board providing a uniform base with outstanding hydraulic and water-repelling properties. Next, glass fibre ProMesh was embedded to add its incredible strength to the render. ProRend Colourtex primer and top coat finished the watertight, yet breathable, façade.

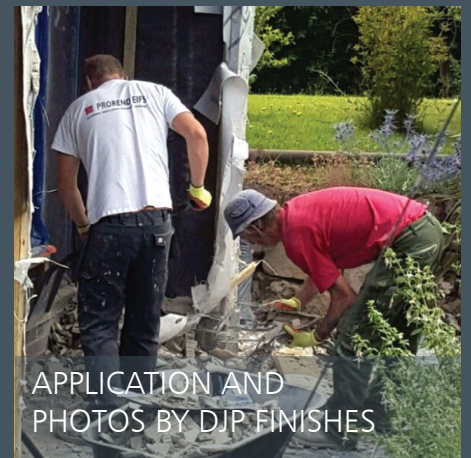
The homeowners were extremely pleased with the low maintenance finish, and their choice of custom colour tinted by SAS Europe.
